Manhole Inspection Summary

Manhole # S17I__017MH

Location Address: **2454 BALTIMORE ST**

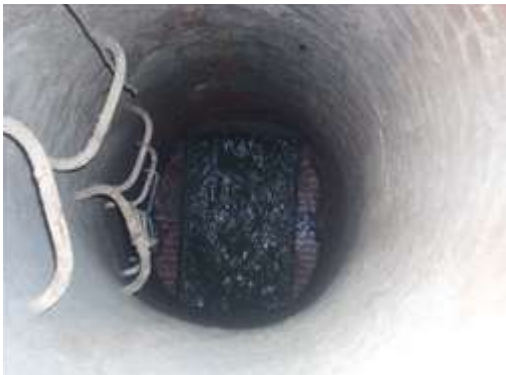
Top View

worn frame

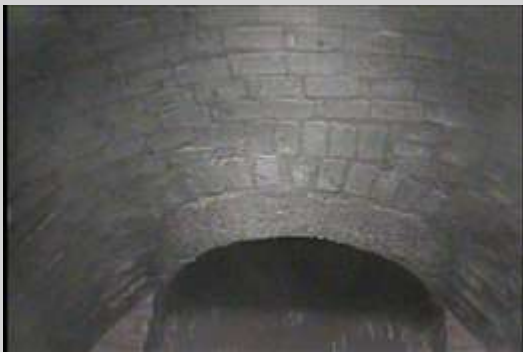
12 O'Clock Outflow

33 in. Circular Gravity Sewer
Pipe Out @ 12 O'Clock

Pipe Height: **33.6** (in.) Direct (Angled)
Pipe Material: **Concrete** ☐ Pipe Lined
Invert Depth: **18.56** (ft.) Flow Characteristics: **Fast**
Deposits: ☒ None ☐ Mud ☐ Sludge ☐ Debris ☐ Grease
Silt Depth: (in.) Deposits Extent:
Infiltration: **None** Pipe Seal Cond: **Sound**

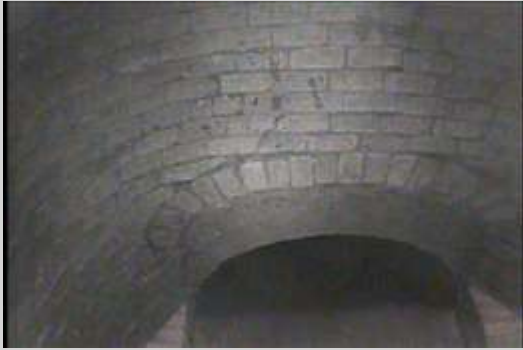
6 O'Clock Inflow

33 in. Circular Gravity Sewer
Pipe In @ 6 O'Clock

Pipe Height: **33.6** (in.) Direct (Angled)

Pipe Material: **Concrete** ☐ Pipe Lined

Infiltration: **None** Pipe Seal Cond: **Sound**
